Expedient Shelter Construction and Occupancy Experiments

OAK RIDGE NATIONAL LABORATORY

HEALTH PHYSICS DIVISION
EMERGENCY TECHNOLOGY SECTION

MARCH 1976

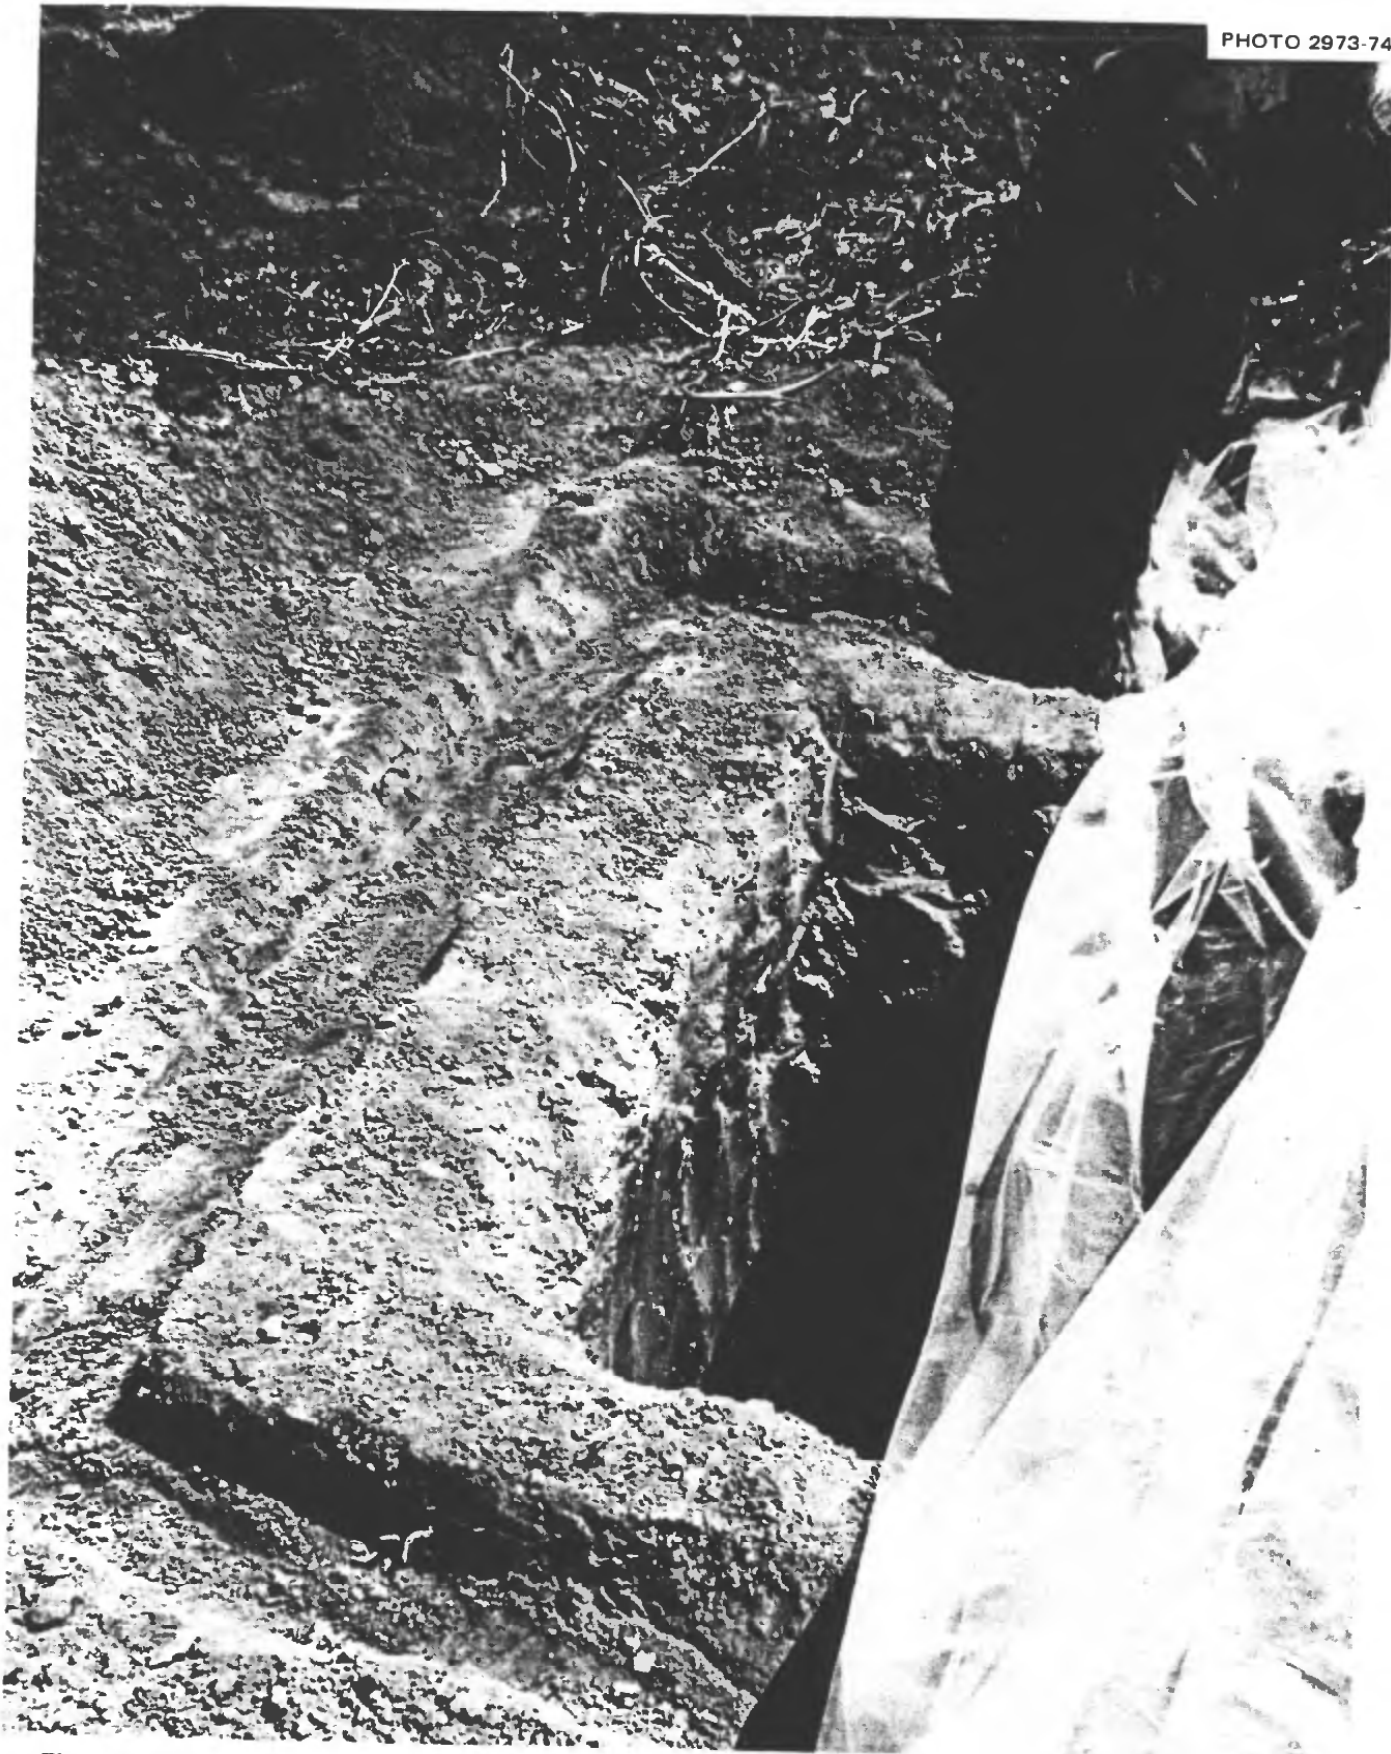
Fig. 4.34. Placing a sheet of 4-mil polyethylene in a 120-gallon water-storage pit. Unlike previous water-storage pits dug and tested by Kearny, this pit was not first lined with cloth or other material to keep sharp roots, etc., from puncturing the waterproofing plastic. All root ends were merely cut off with a knife. The edges of the plastic were folded into the small side trenches, and then held by packed earth. Six days after being filled, no leaks had developed.

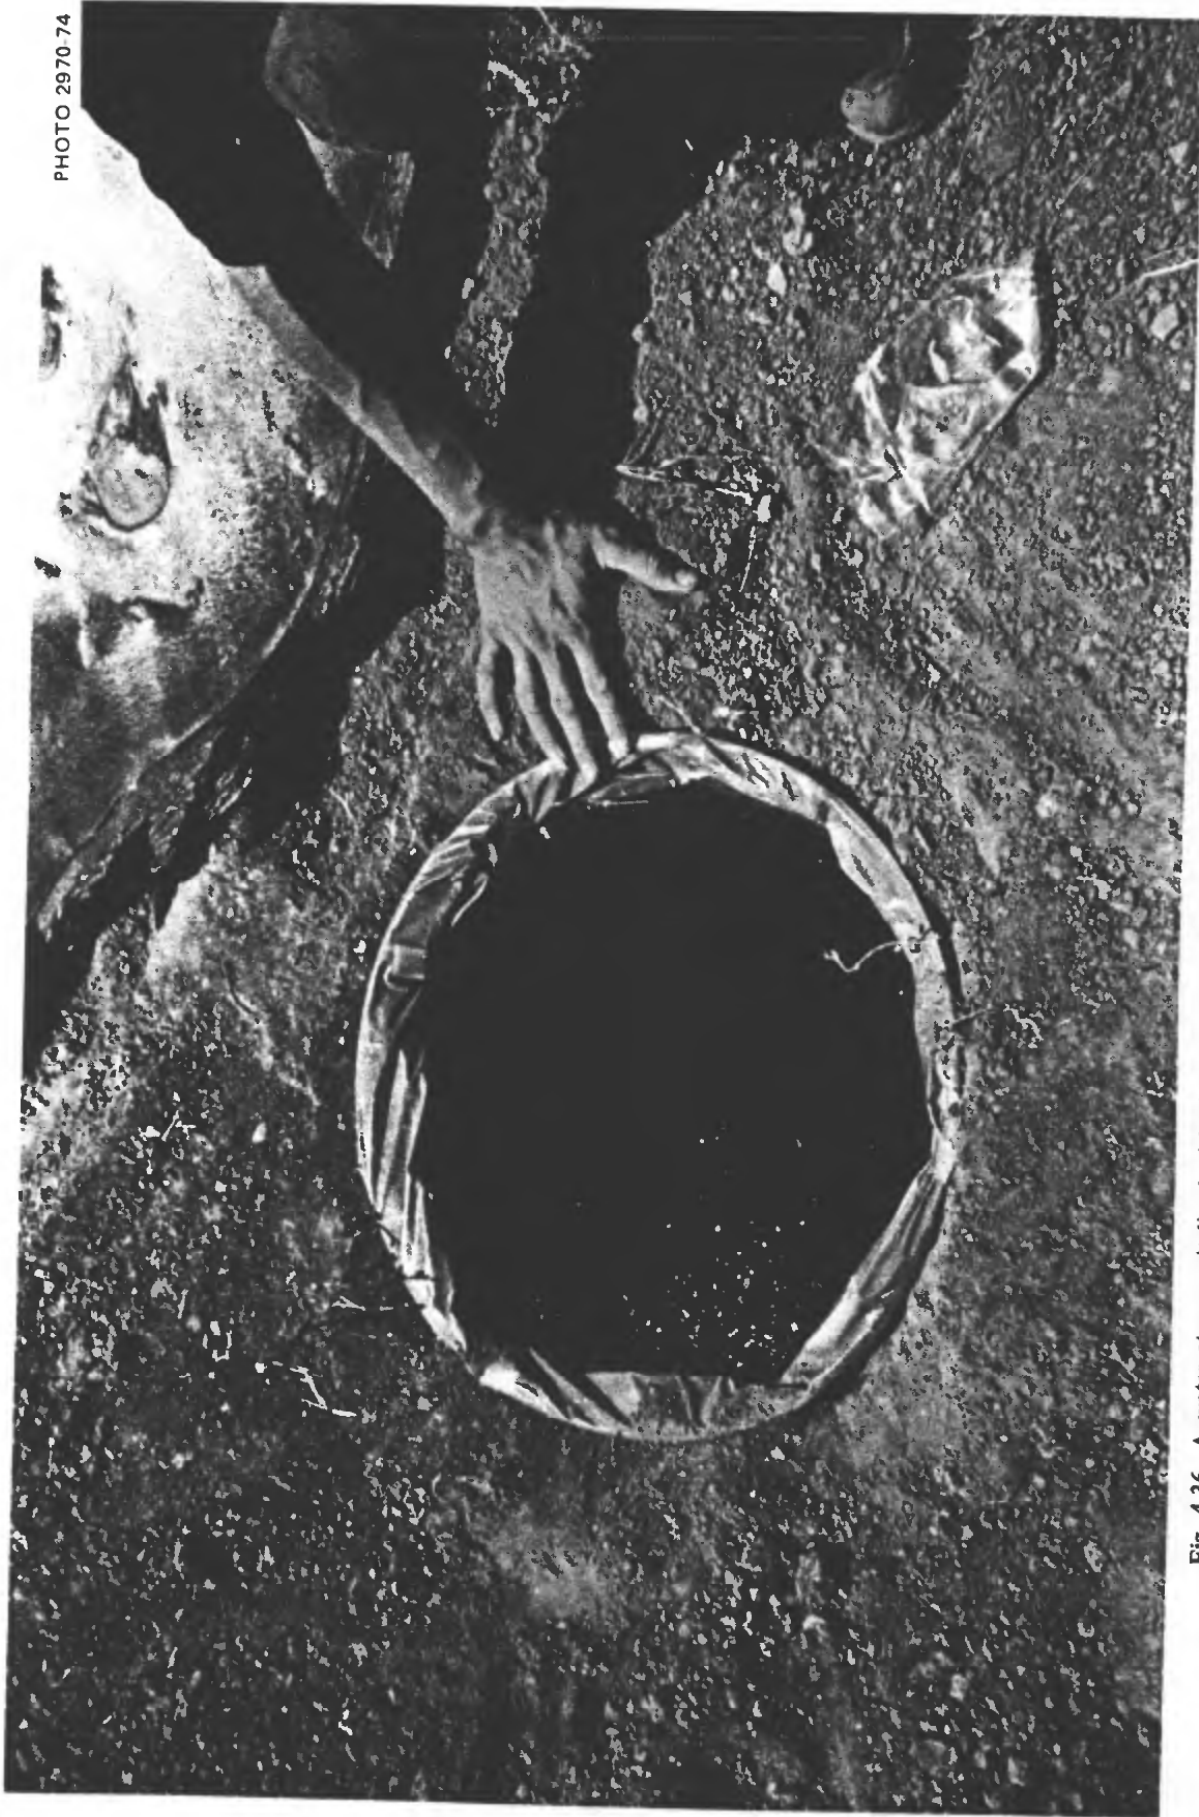
Fig. 4.36. A water storage pit lined with plastic bags, photographed 6 days after having been filled and covered. None of the approximately 25 gallons of water in this pit had leaked through the two 30-gallon trash bags (each about 1 1/4 mils thick) placed one inside the other for a pit lining.

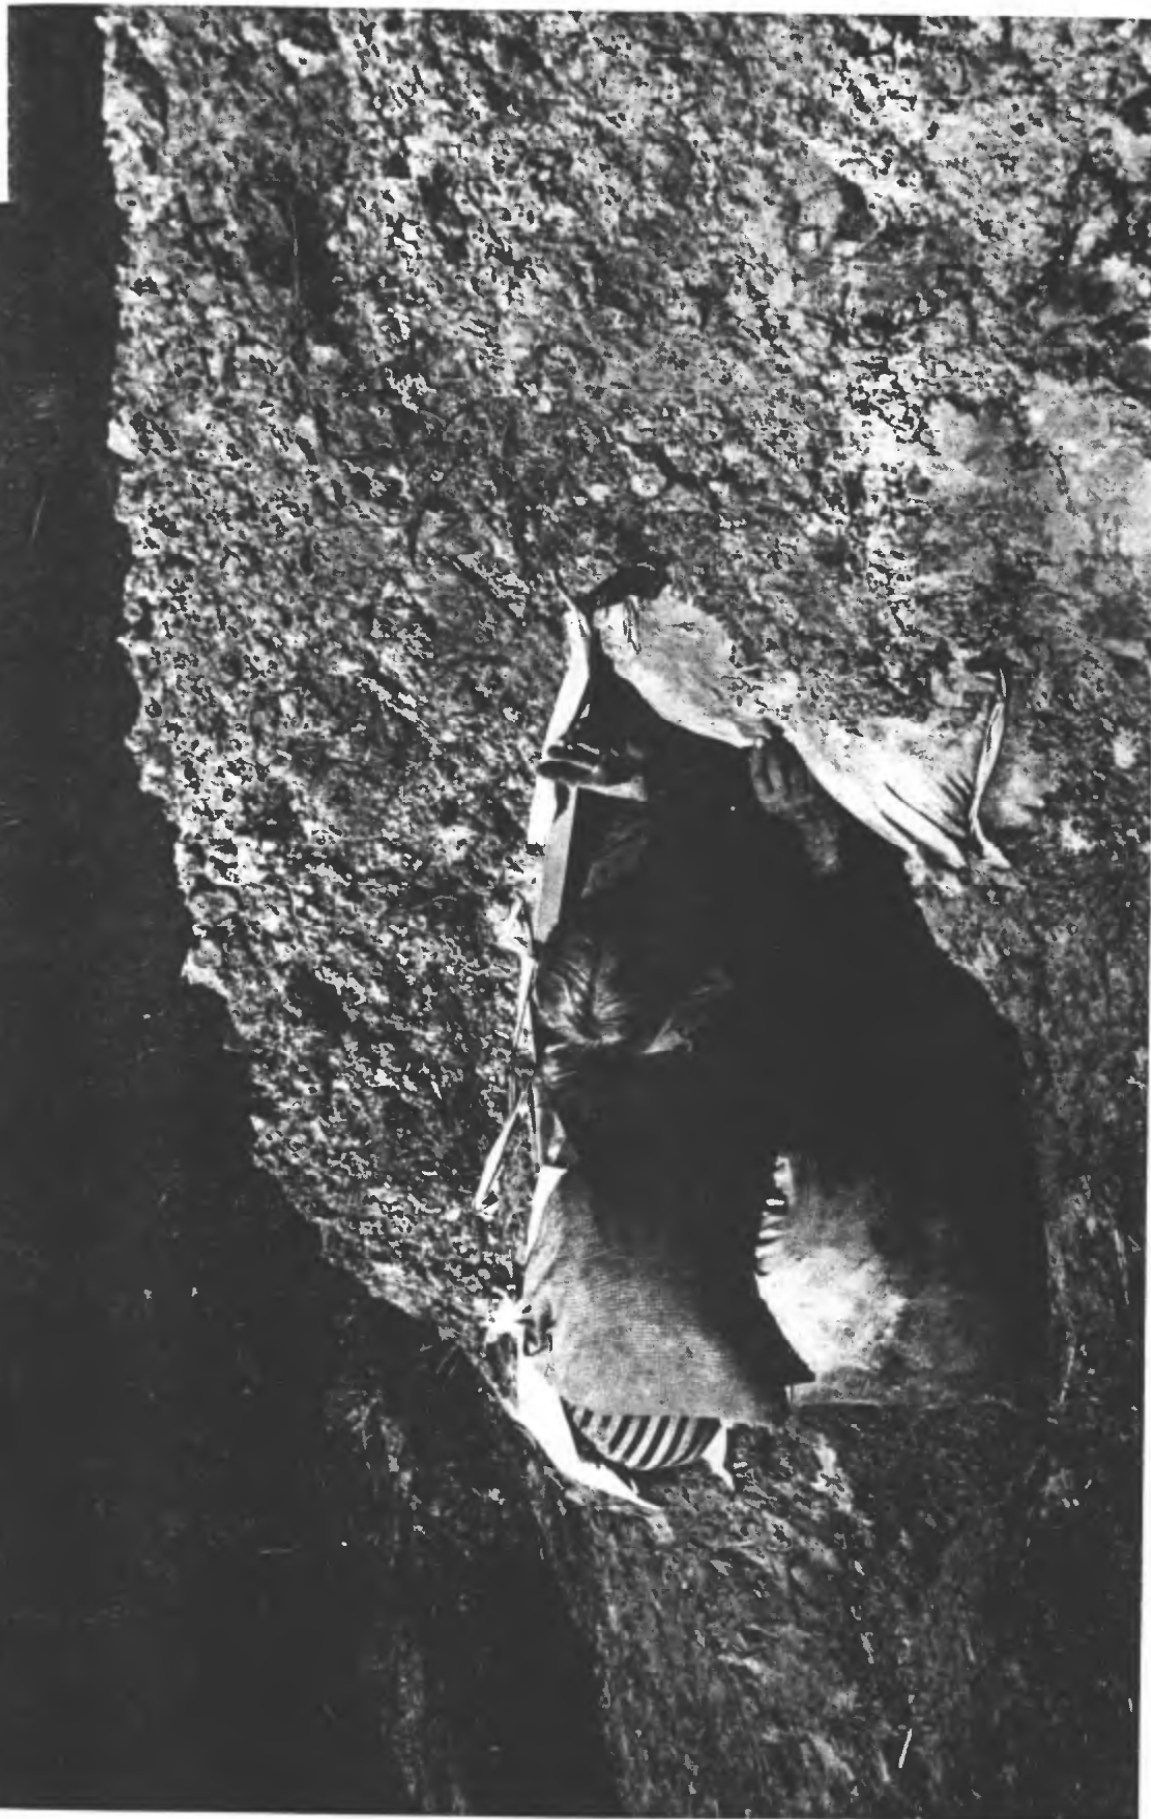
Fig 5.10. A closeup view of the same entry pictured previously, showing the sandbags used to finish the ends of the entryway walls and to reduce radiation from fallout on the ground, which otherwise would enter the shelter.

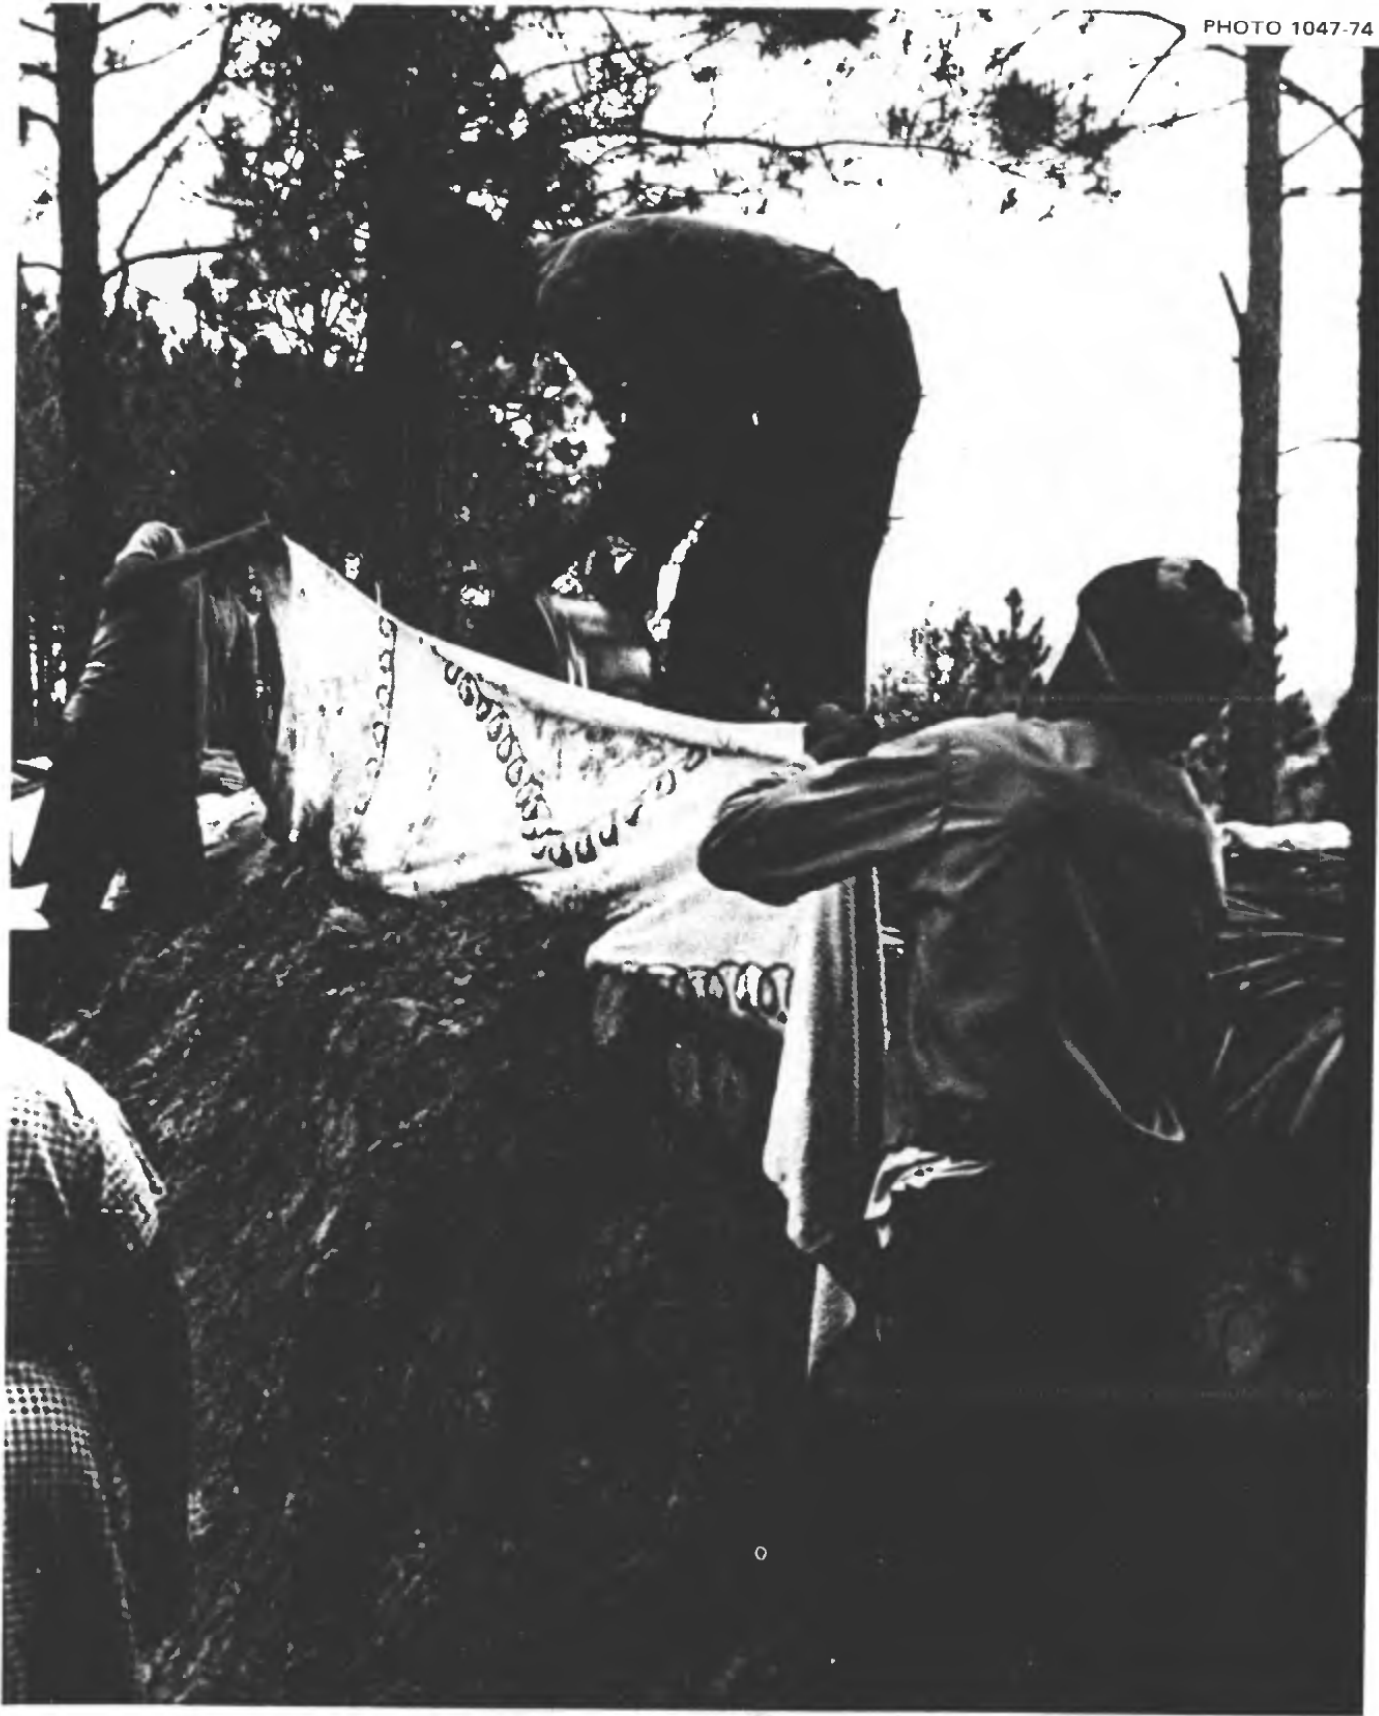
Fig. 5.22. Using an old bedspread to form an earth-filled roll along an upper edge of the essentially flat shelter roof of poles. The father is pouring earth out of a large bucket. These rolls made it possible to increase the stability of the earth covering around the edges of the roof, and also prevented heavy rains from washing any appreciable amount of shielding earth off the shelter roof.

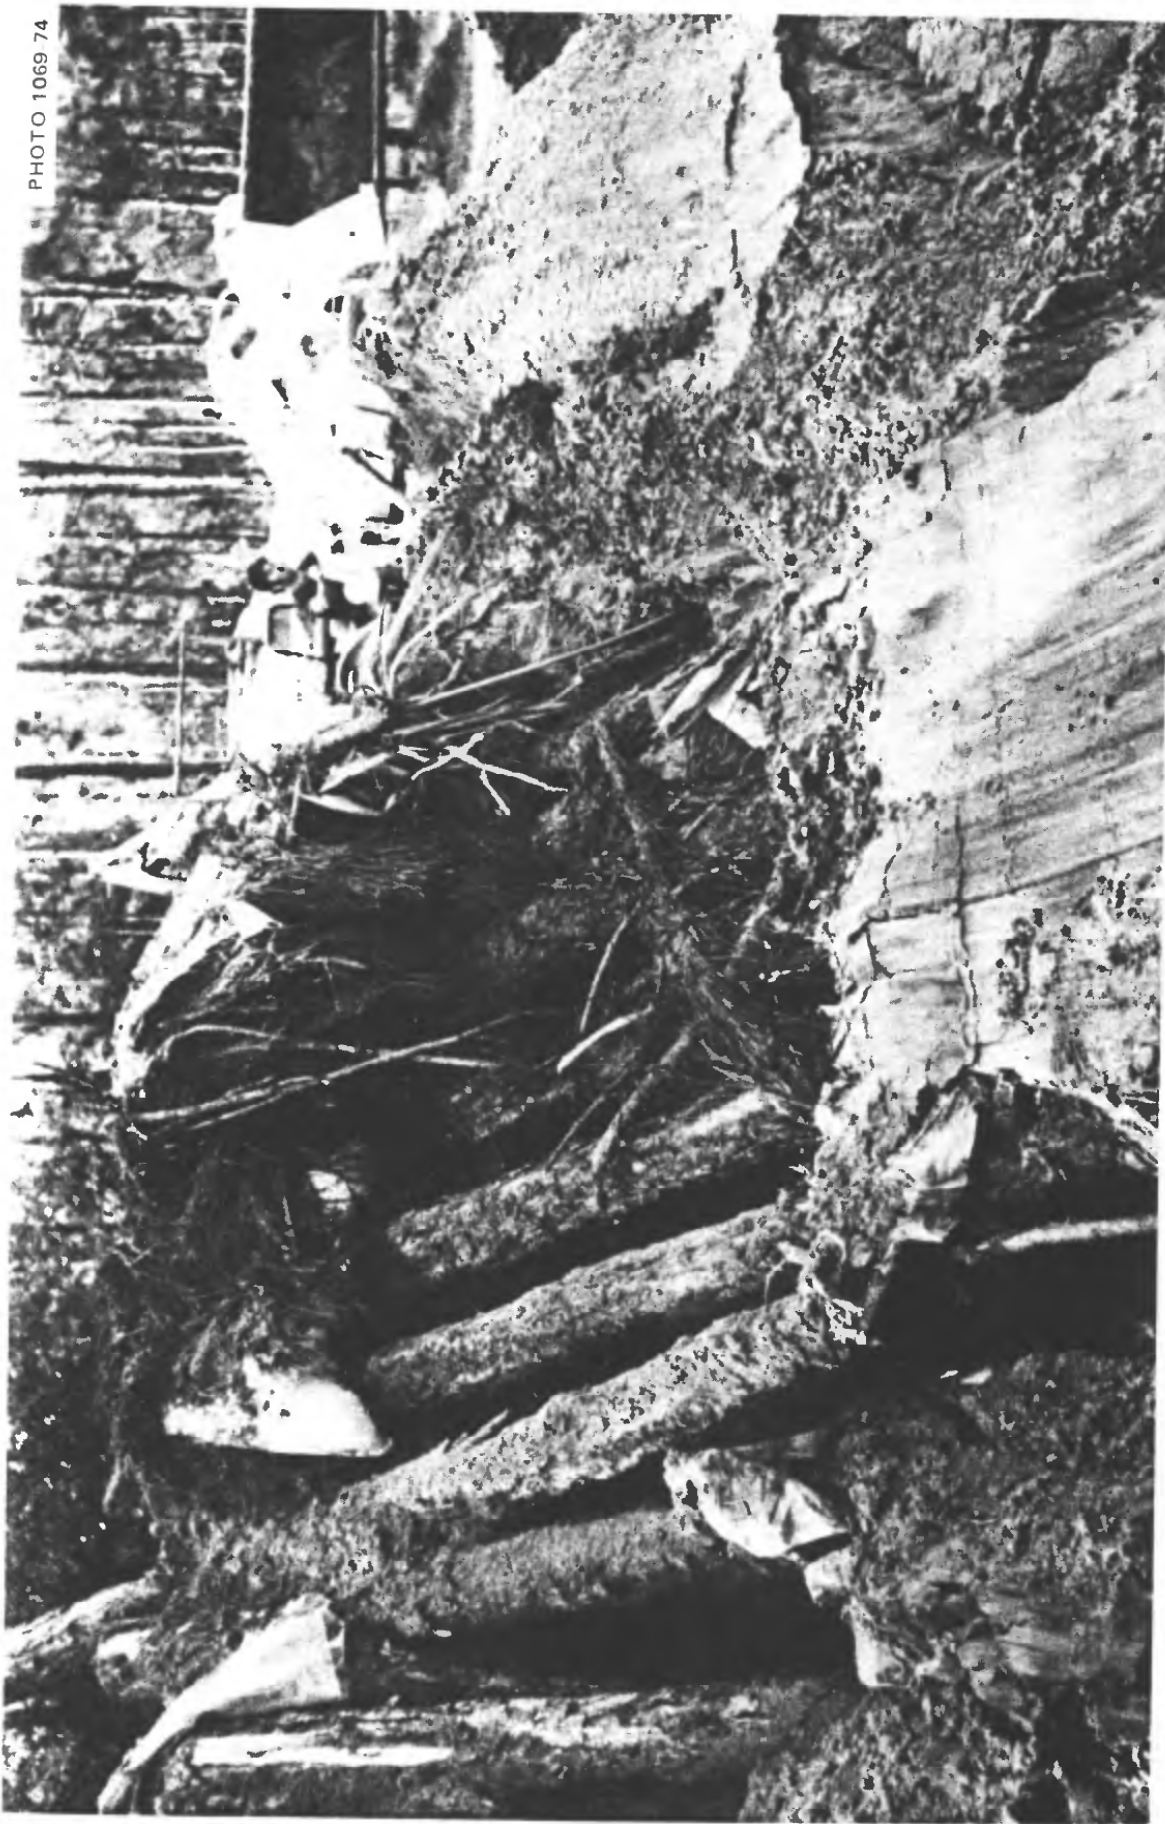
Fig. 5.40. View after a backhoe had started to demolish the Waldens' Ridge-Pole Shelter, which proved to be decidedly sturdy. Note that some of the wall poles were broken before they were moved off the ridge poles, or the ridge pole had been moved significantly.

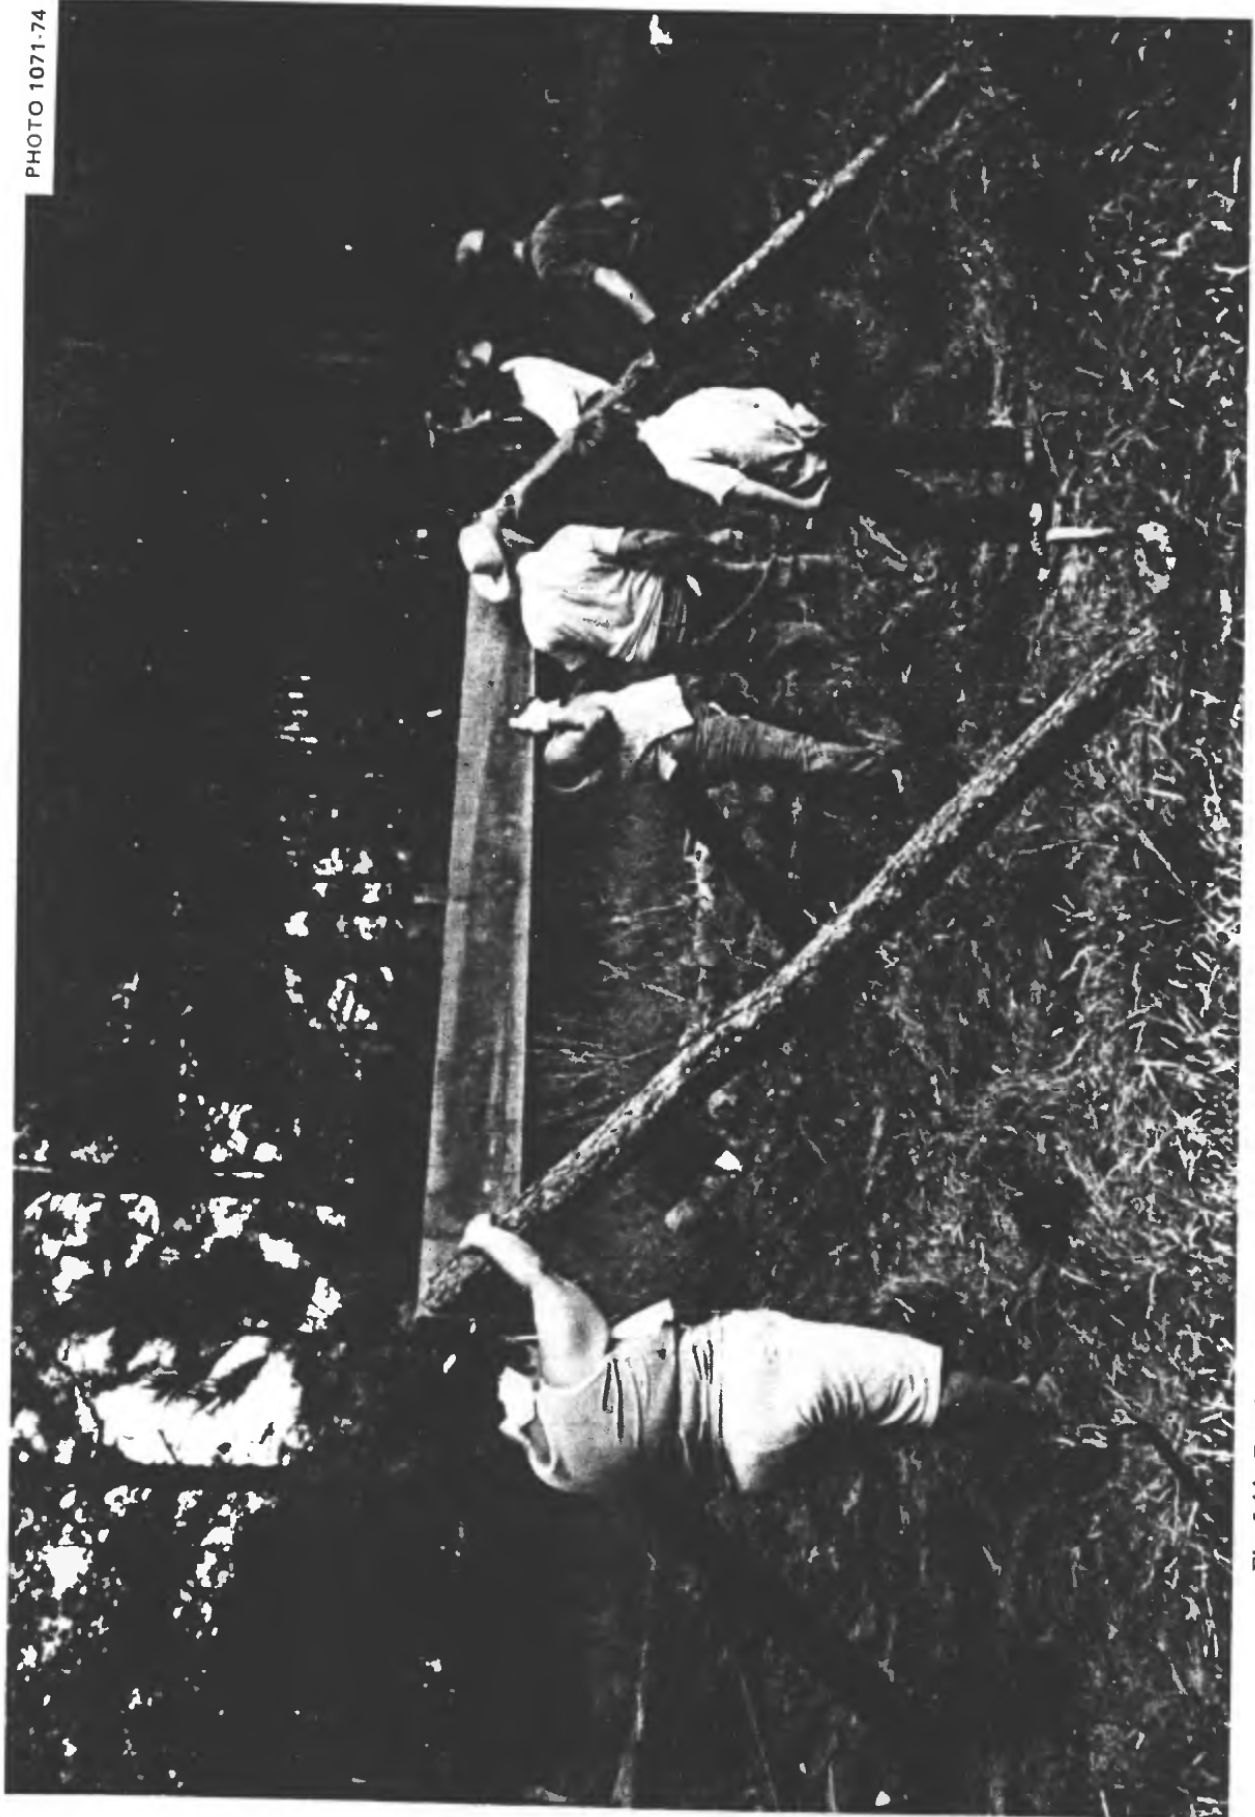
Fig. 5.44. Erecting a 16-ft-long section of the ridge board that later was extended to a 21-ft length. These decidedly competent rural people were so overconfident of their building abilities that they failed to read the instructions carefully. As a result, they made several errors that they had to correct. One of these errors was initially using a 5-in.-wide board for the first part of the ridge board; they found that the upper ends of some of the wall poles would not fit properly against a board so narrow.

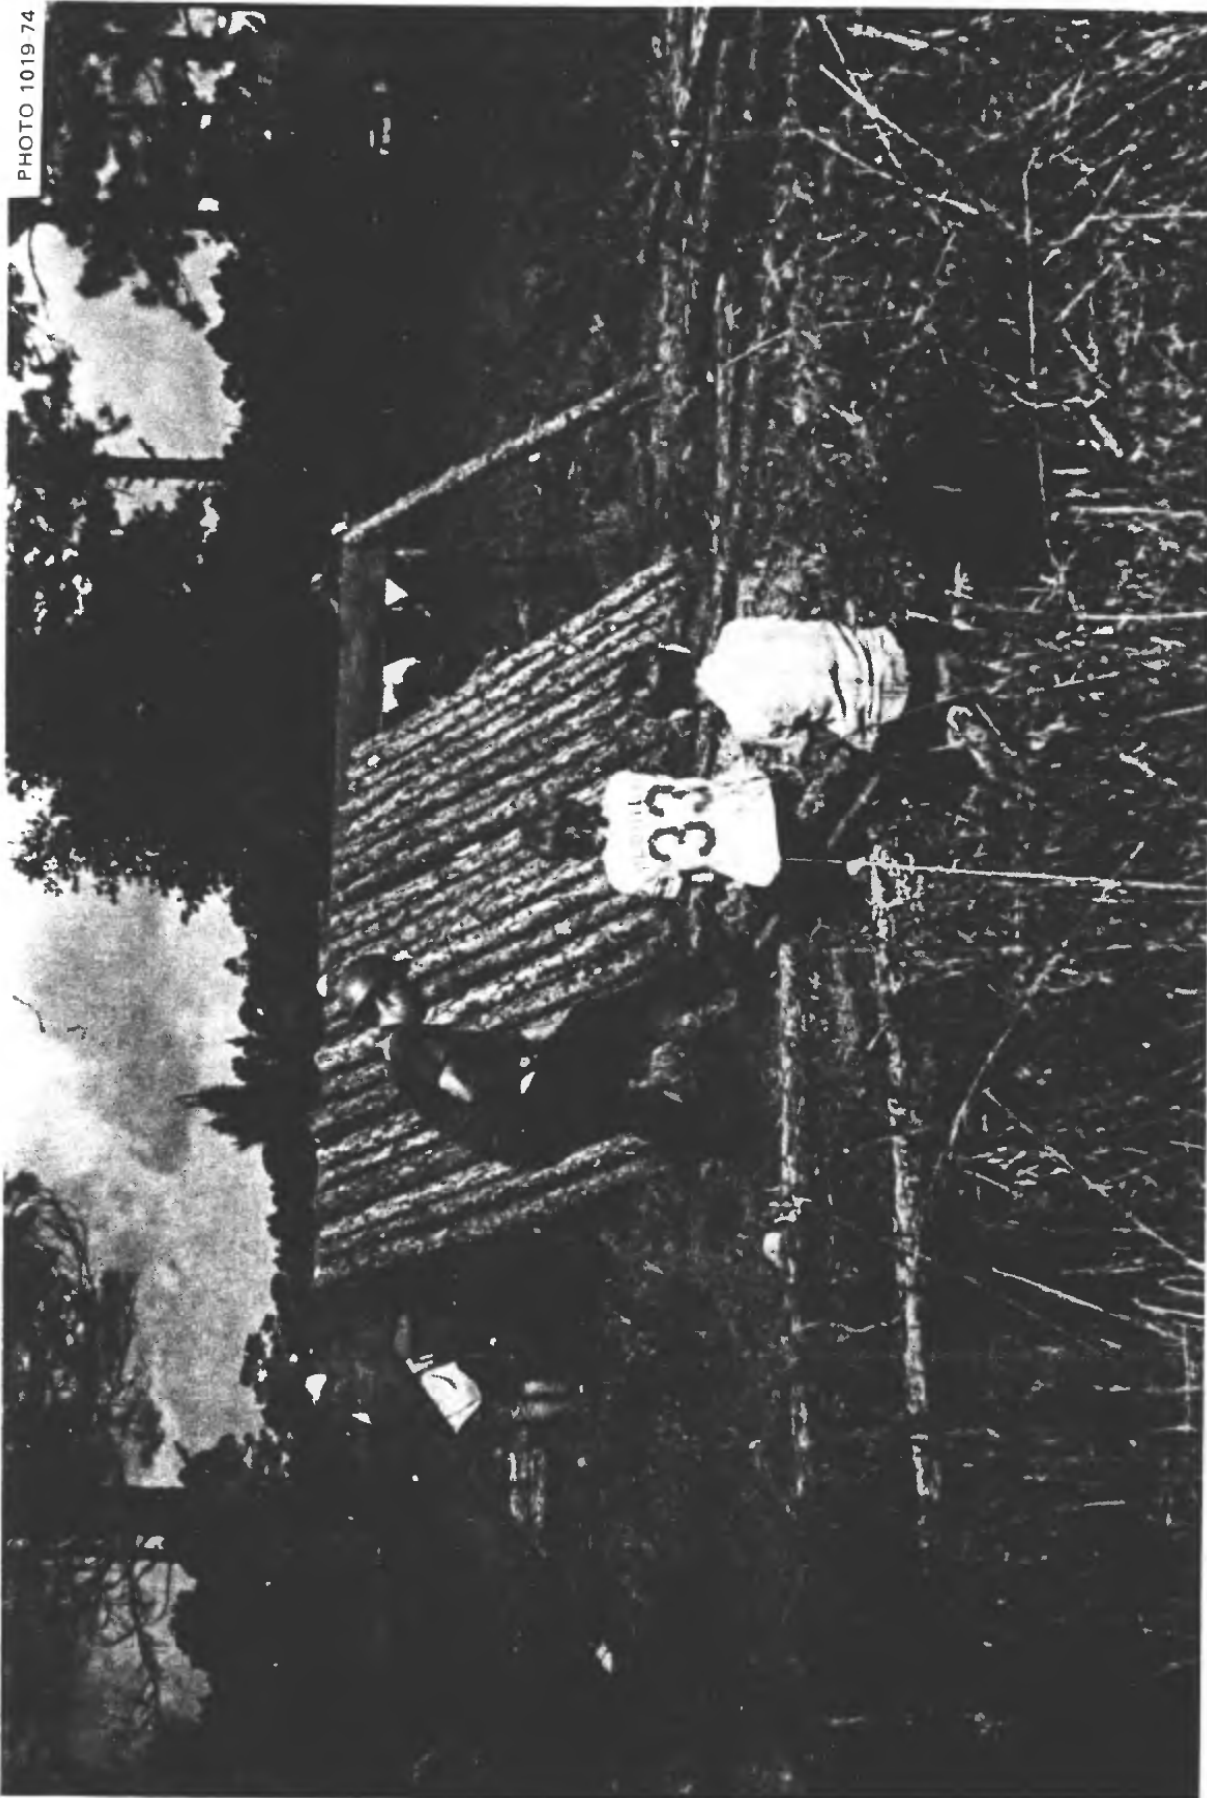
Fig. 5.45. Chain saw operator using a templet to cut an upper end of a wall pole at the specified 54° angle and 9-ft length on its short side. The templet was made from a wide 10-ft board, with one end cut at 54° . A nail was driven 9 ft from the end of this 54° angle; the squared-off base of the pole was placed against this nail.
